## 8-22 LOWER UNIT

### 8-6 TYPE II LOWER UNIT SERVICE MANUAL SHIFT -- SINGLE ENCLOSED HOUSING

60 HP -- 1 $\frac{1}{4}$  THRU 1 $\frac{1}{2}$   
 65 HP -- 1968  
 75 HP -- 1960 THRU 1965  
 80 HP -- 1966 AND 1967  
 85 HP -- 1 $\frac{1}{8}$

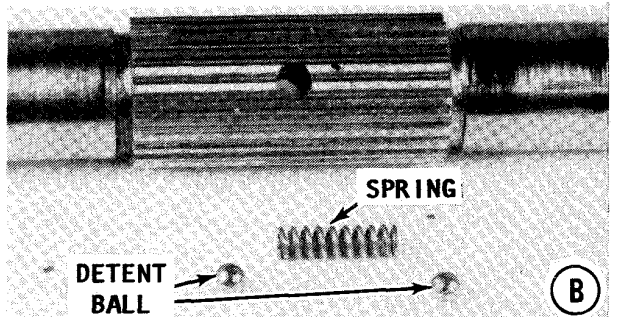
As a result of this condition, a service bulletin, fixture, new clutch dog, and associated parts, were dispatched from the factory, Illustration "A". Service centers were instructed to modify the lower unit any time it was disassembled. A hole was drilled through the propeller shaft, Illustration "B". A spring and two balls, provided in the package, were installed on the propeller shaft, one on either side. A groove had been cut into the inside diameter of the new clutch dog. When the new clutch dog is placed in the **NEUTRAL** position, the groove

is over the balls. The spring exerts a force on the balls to hold the clutch dog in position.

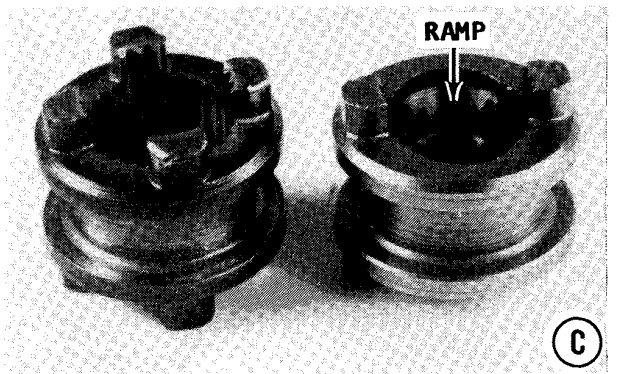
Two ramps are manufactured on the inside surface of the clutch dog, one towards the forward gear, and the other towards the reverse gear, Illustration "C". As the clutch dog is moved toward either forward or reverse gear, the spring and balls exert a small force on the clutch dog to prevent the "chattering".

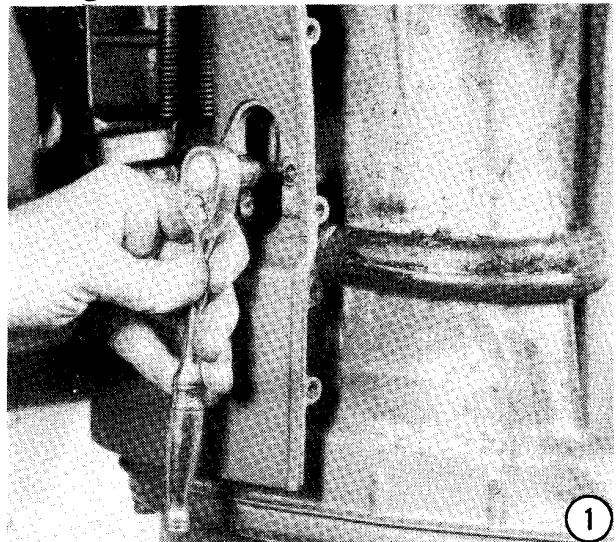
1- Observe the shift rod connection through the windows. If the engine does not have the long extension, the connector will be about 1-1/4" (3.18 cm) long. Remove the lower screw in the connector. After the screw is loose, it may be necessary to grasp it with a pair of needle-nose pliers in order to withdraw it from the connector.

2- If the unit being serviced has the long shaft extension, remove the eight bolts securing the lower unit to the extension.
